**Washington State Ferry Terminal
Structural Inspection**
By the Bridge Preservation Office

Kingston Ferry Terminal

Location	Bridge No.	Type	Inspection Date	Report Received
Slip 2	104/10FT	Routine & FC	9/10/2019	11/18/2019

Br. Name KINGSTON (MAIN - SLIP 2)

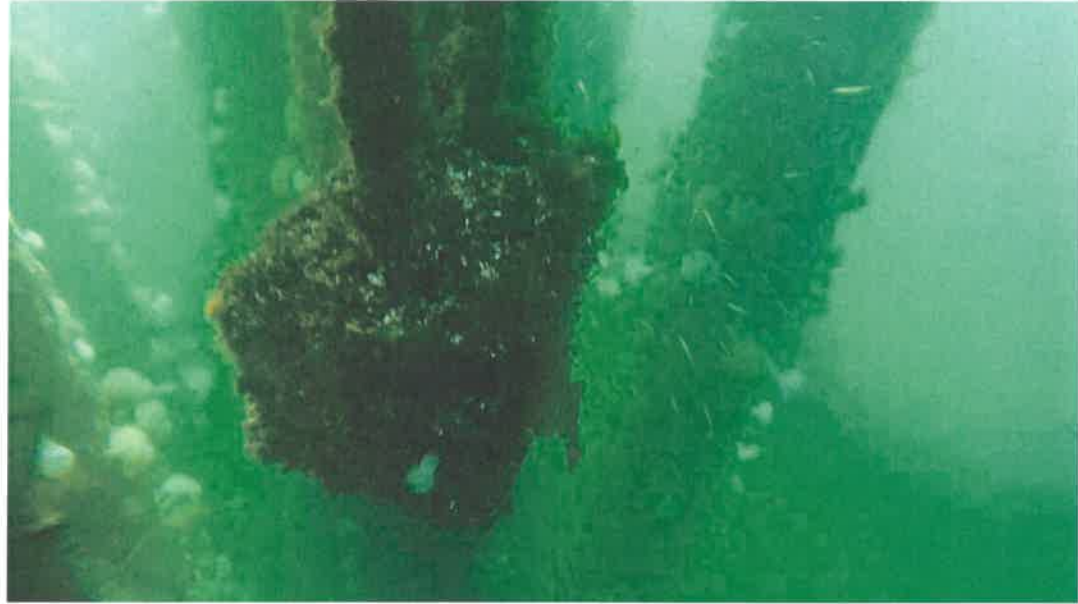
Slip 2 right outer dolphin (RO) ladder is intact with sinker block attached to bottom with some section loss of hardware at connection.

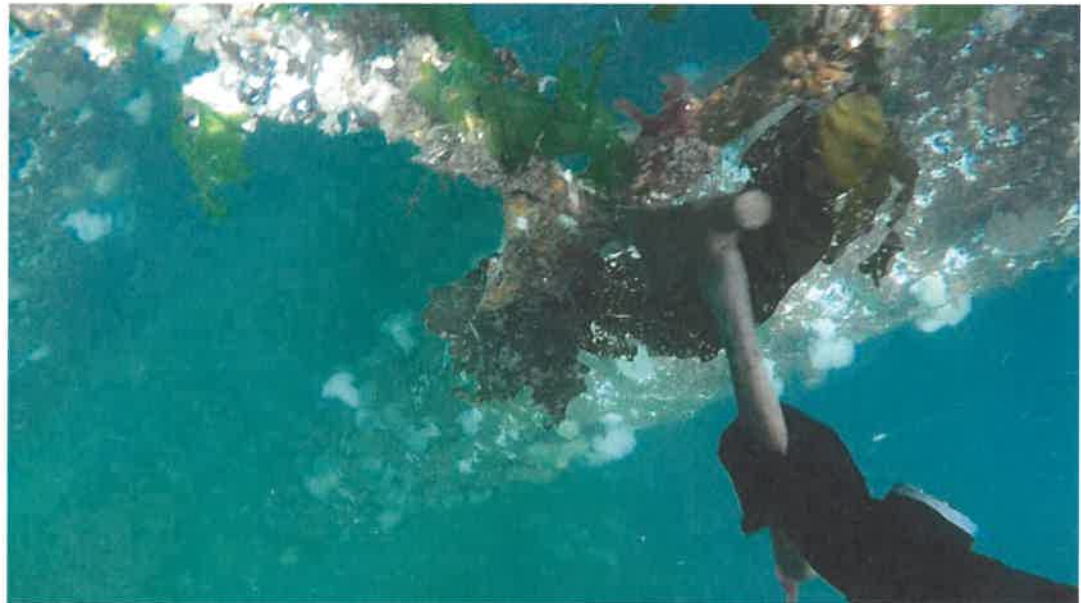
UW-16

Tie-up Slip 3 left outer dolphin (TLO) ladder sinker block is detached from the ladder and is resting on the bottom directly below the hanging ladder between Piles 3C and 3D.

Recommend re-attaching sinker blocks to ladders on Slip 2 inner left, Tie-up Slip 3 outer left and outer right dolphins. Maintain a 60-month underwater inspection frequency.

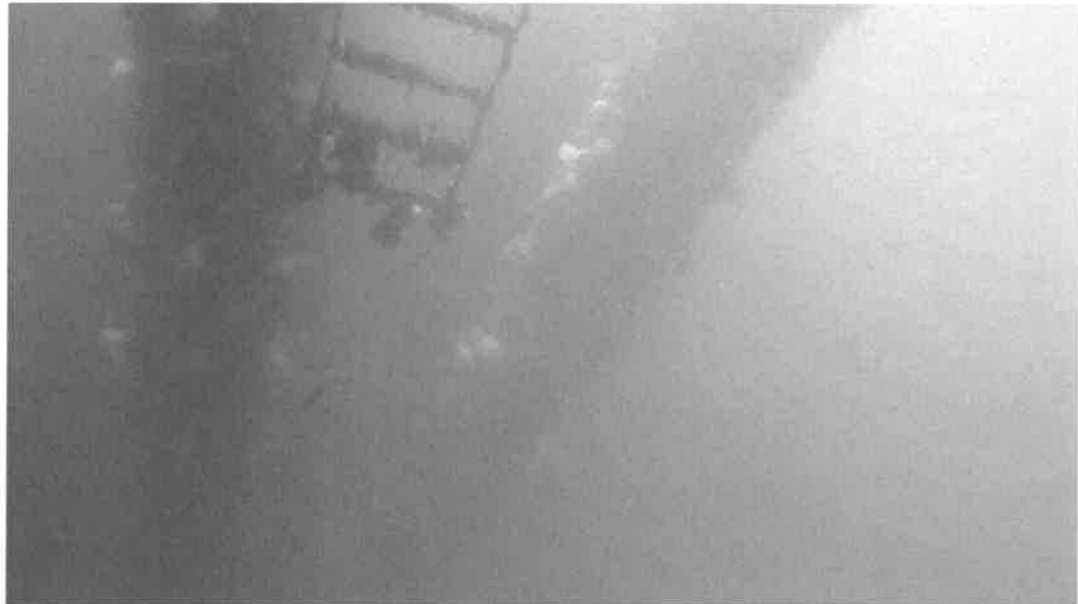
Tie-up Slip 3 right outer dolphin (TRO)
ladder sinker block is detached. Color
reduced for clarity.

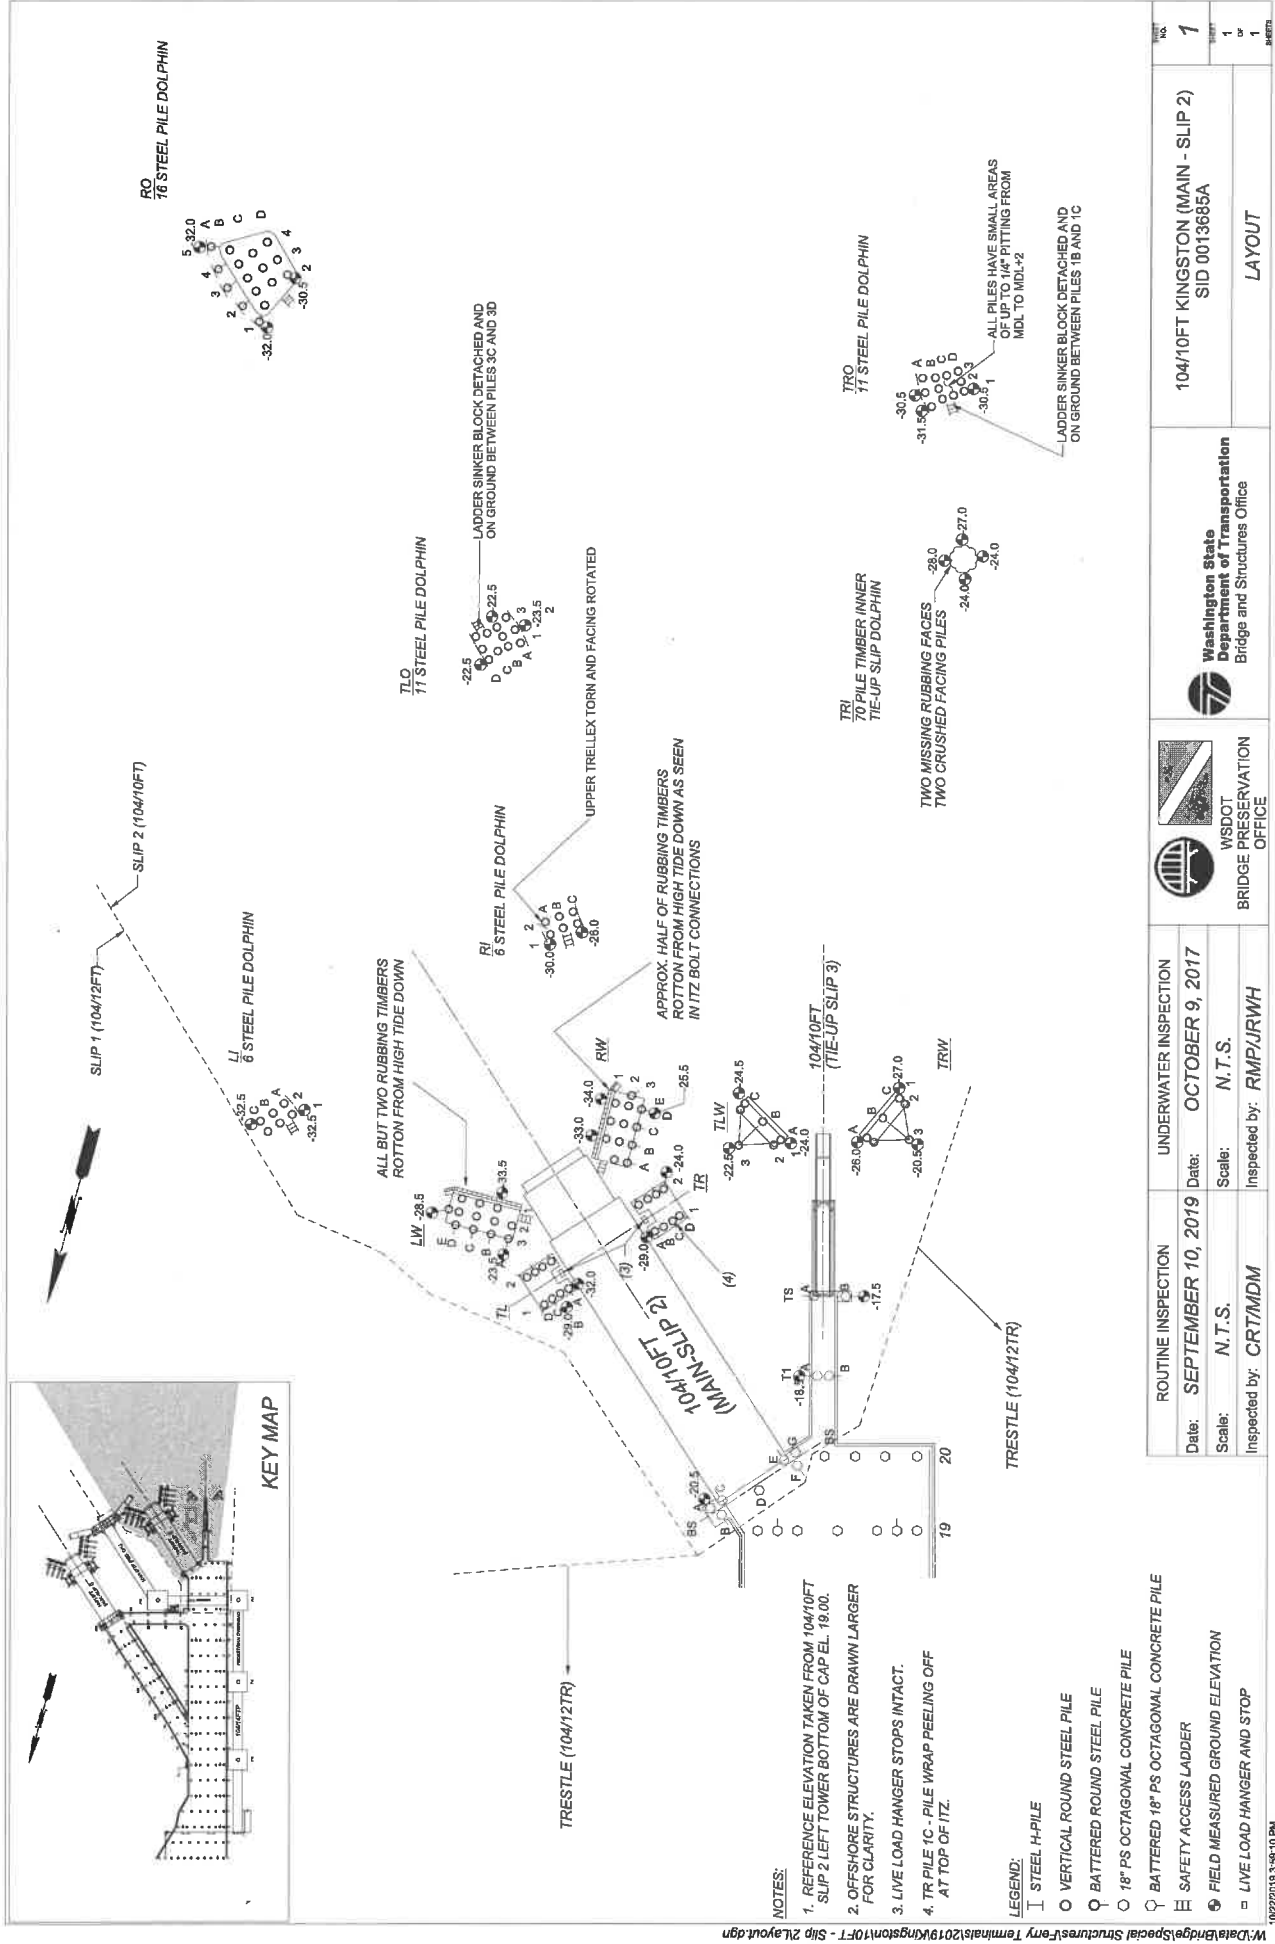
- NOTES:**
1. REFERENCE ELEVATION TAKEN FROM 104/10FT SLIP 2 LEFT TOWER BOTTOM OF CAP EL. 19.00.
 2. OFFSHORE STRUCTURES ARE DRAWN LARGER FOR CLARITY.
 3. LIVE LOAD HANGER STOPS INTACT.
 4. TR PILE 1C - PILE WRAP PEELING OFF AT TOP OF ITZ.
